Bell and Fraser Lake Beaver Deceiver

Prepared by David Frere

This document outlines the beaver deceiver installed at the discharge of Bell lake into the culvert under highway 366. It is fully constructed and fully operational. Though the beavers have been active since installation, the system is working as designed. At the time of writing, the lake levels are high but that is due to the high amount of rain we have received recently and throughout the summer. The lake levels should drop to more normal levels soon. No clearing of debris or damming materials has taken place since installation. No maintenance of the system has been necessary and each component is in good shape. Despite this, I will continue to inspect the installation and report on any deficiencies until next summer.

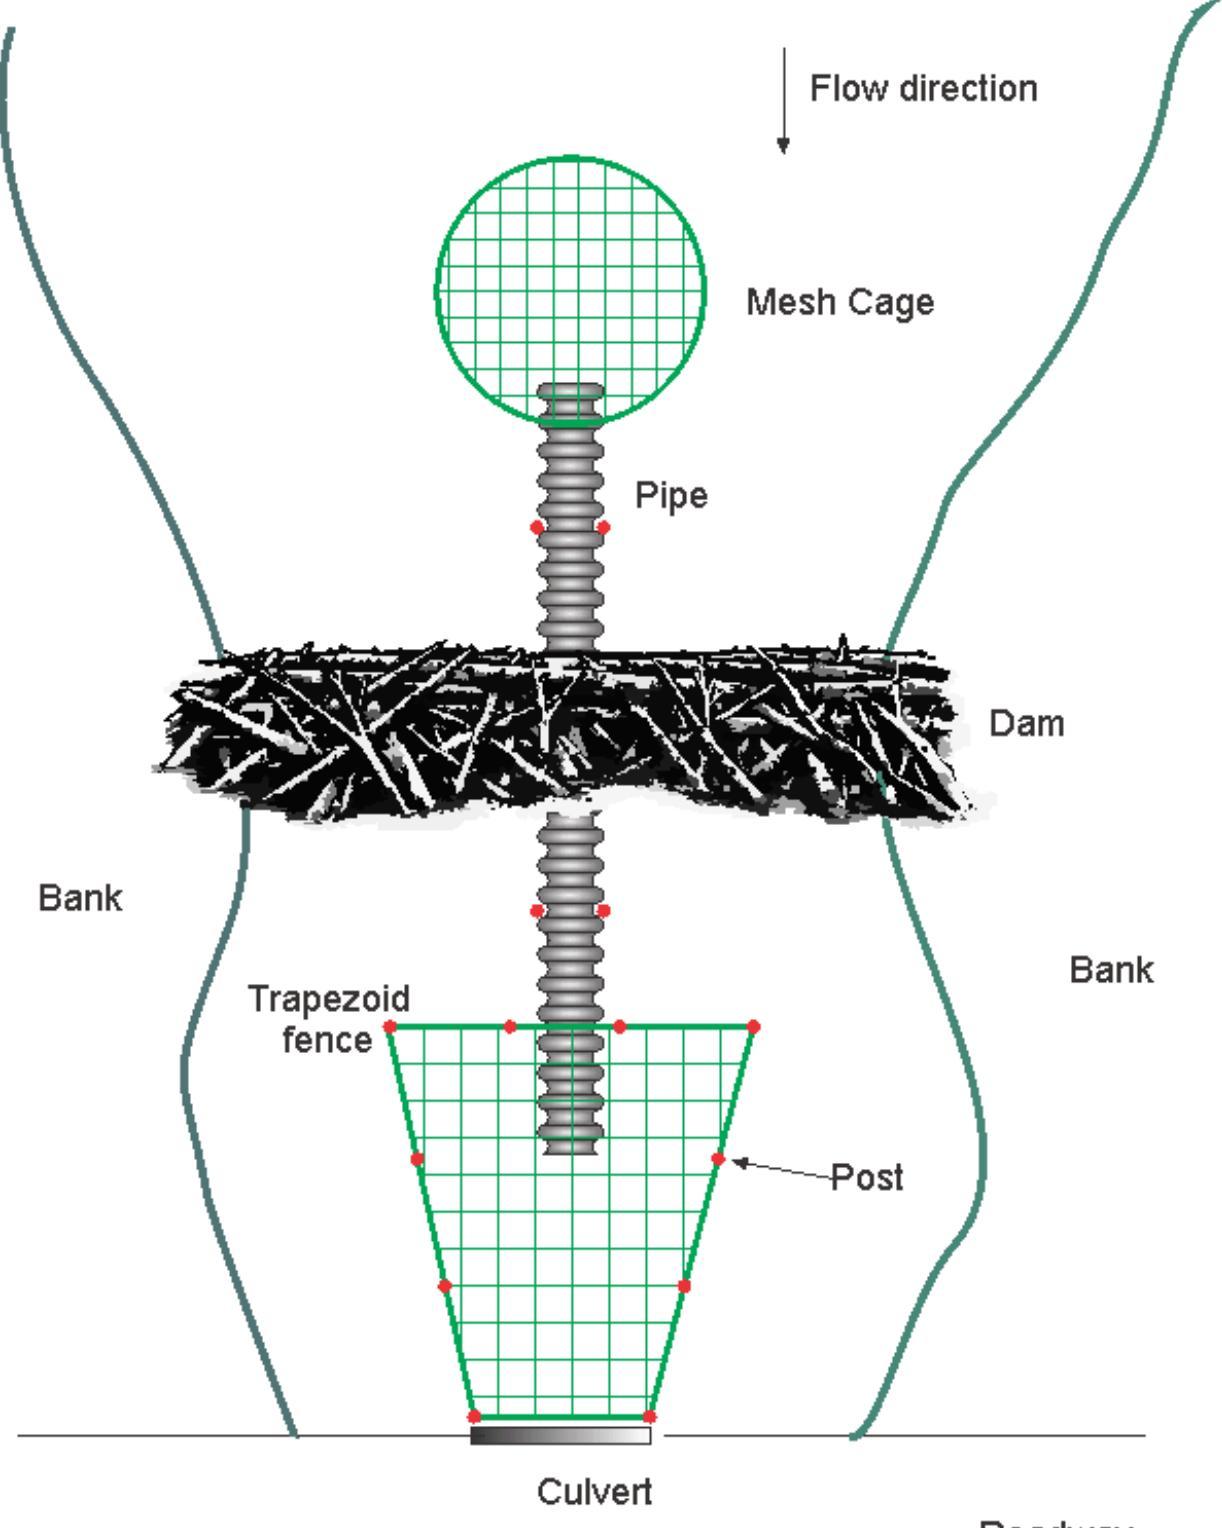
Figure 1: Plan View (not to scale)

The original design called for four different components, namely:

- 1. The trapezoid at the culvert
- 2. The pipe leading upstream
- 3. The inlet cage
- 4. The fake dam over the pipe

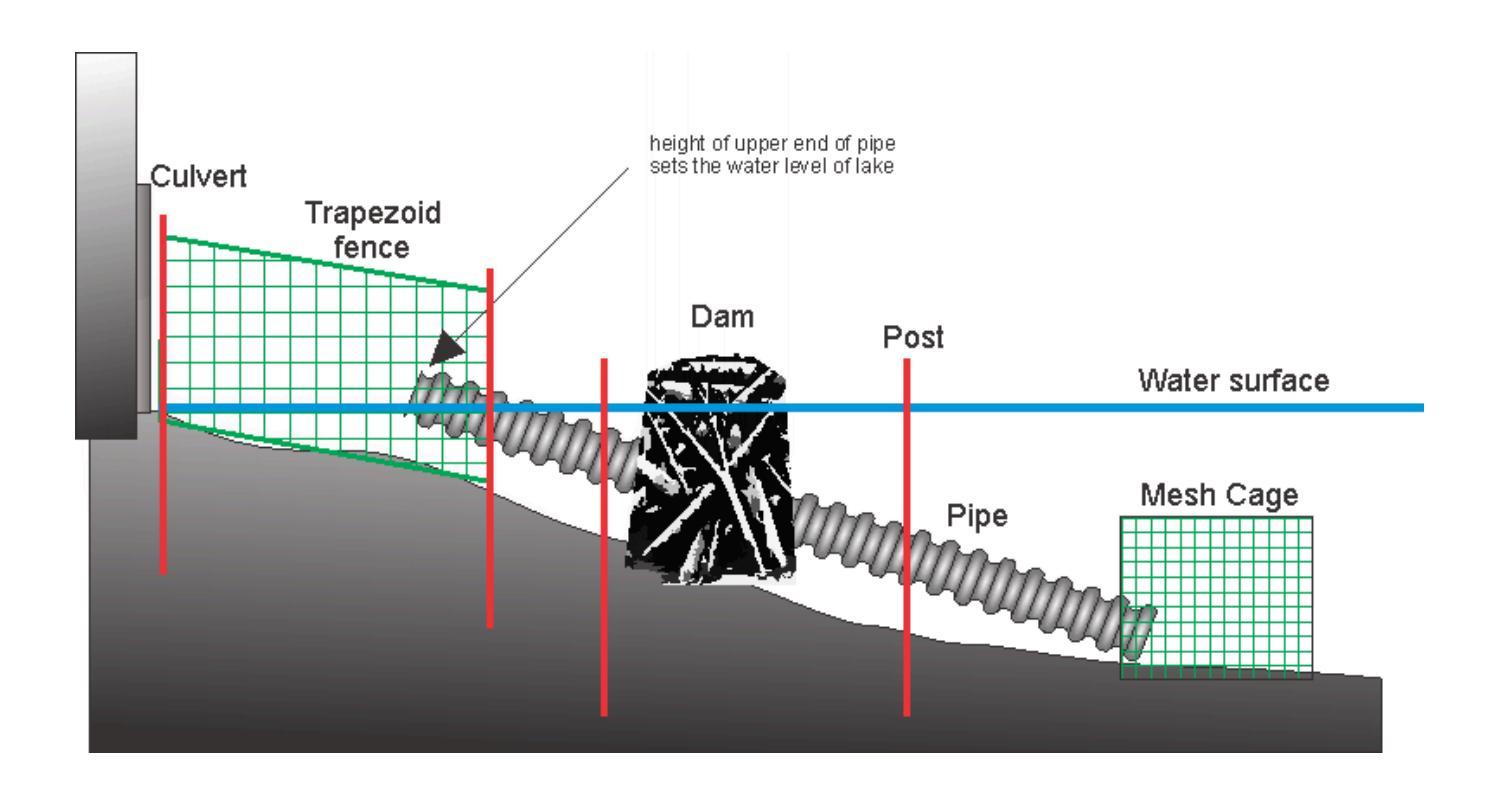
Figure 2: Side View (flow direction is from right to left)

In addition to the culvert fencing, a pipe was to be installed through the fence wall, leading to a deeper part of the water upstream. The pipe itself needed to be of sufficient diameter to allow a decent flow of water and be of a durable material. Cinder blocks attached with wire were to be installed at various points along the length of the pipe in order to ensure that the pipe stayed below the water level. If, for any reason, the pipe were to rise above the lake level, then flow would cease. Drilling of holes along the top of the pipe at about a two foot interval would allow any trapped gases to escape and lessen the chance of the pipe wanting to float up.

The inlet of this pipe was to be protected with a cylindrical mesh cage making it difficult, if not impossible for any beaver to plug it up. The cylindrical cage needed to be of sufficient diameter to keep the beavers from reaching the inlet and have a similar mesh size to the trapezoid. This would keep the beavers from getting in yet allow any smaller fish or wildlife to pass through. The pipe inlet needed to be underwater to keep the beavers from hearing any gurgling sounds which usually makes them want to dam it up.

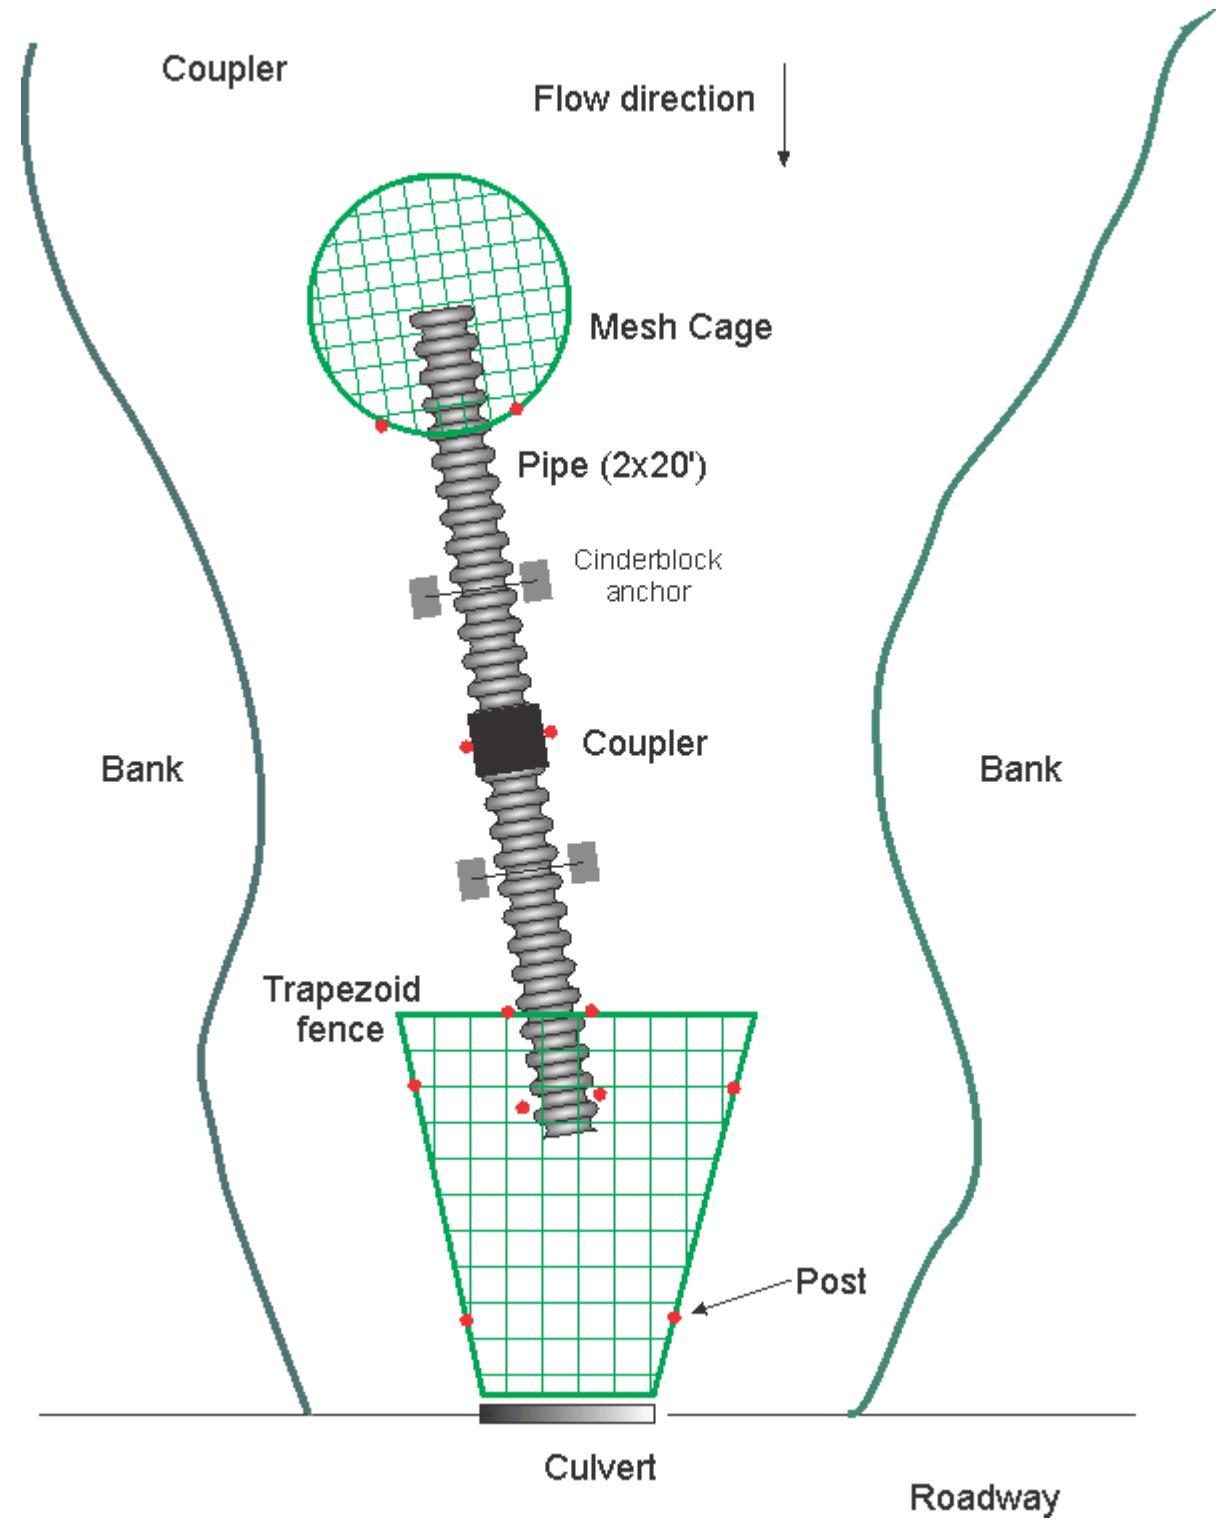
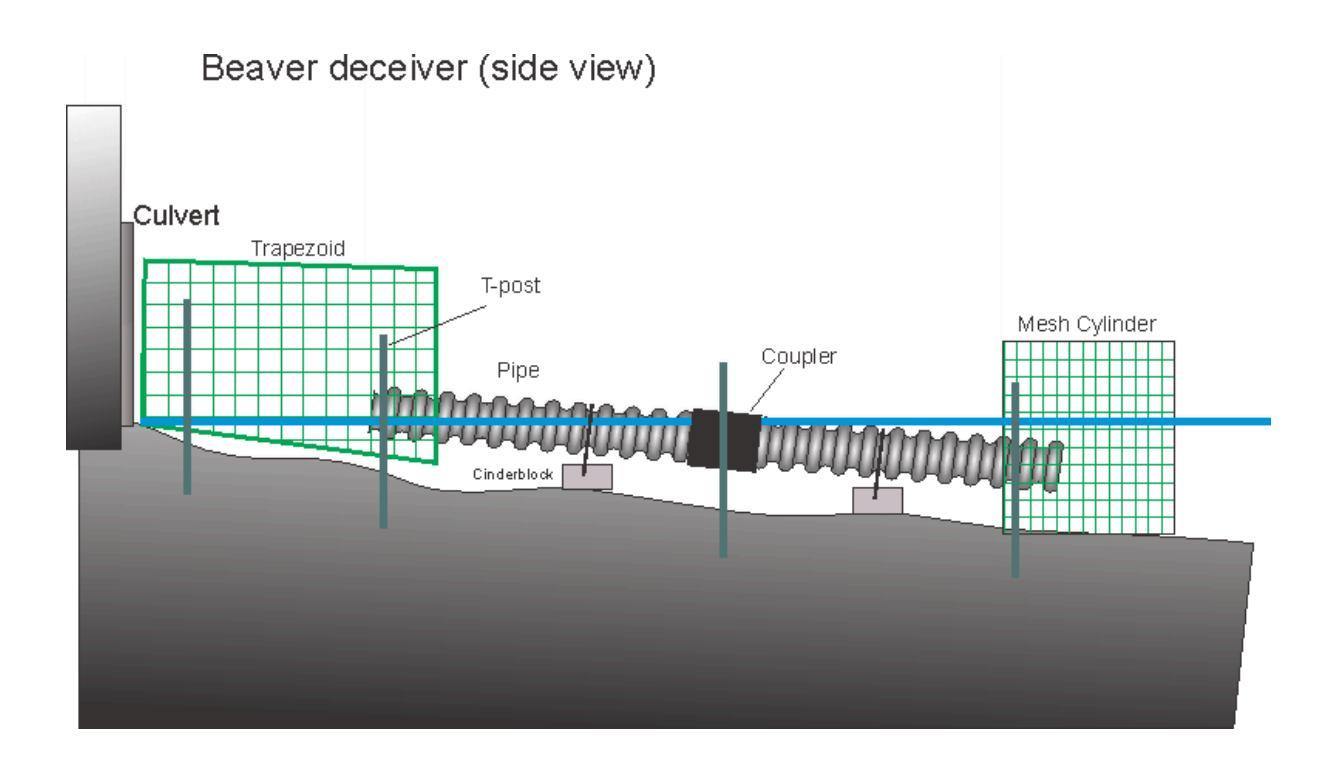
Beaver deceiver, as built (not to scale)

The actual design (the one built and installed) did not differ in too many ways from the proposed design except for the "fake" dam.

The two lengths of plastic pipe were joined and secured. One end was placed through the wall of the cylinder and securely wired with the inlet located close to the centre and off the bottom. Holes were drilled along the top of the pipe to allow gases to escape. At this point, the cylinder/pipe assembly was dragged to an appropriate location upstream. It is worth noting that though the initial location that was selected was quite deep enough, the bottom at that point was very silty and would likely have plugged up the inlet, rendering it useless. The cylinder was moved aside to a shallower location with a firmer bottom yet still deep enough to keep the inlet underwater.

The other end of the pipe was placed through the wall of the trapezoid with the inlet secured further in with the aid of two more T-posts.

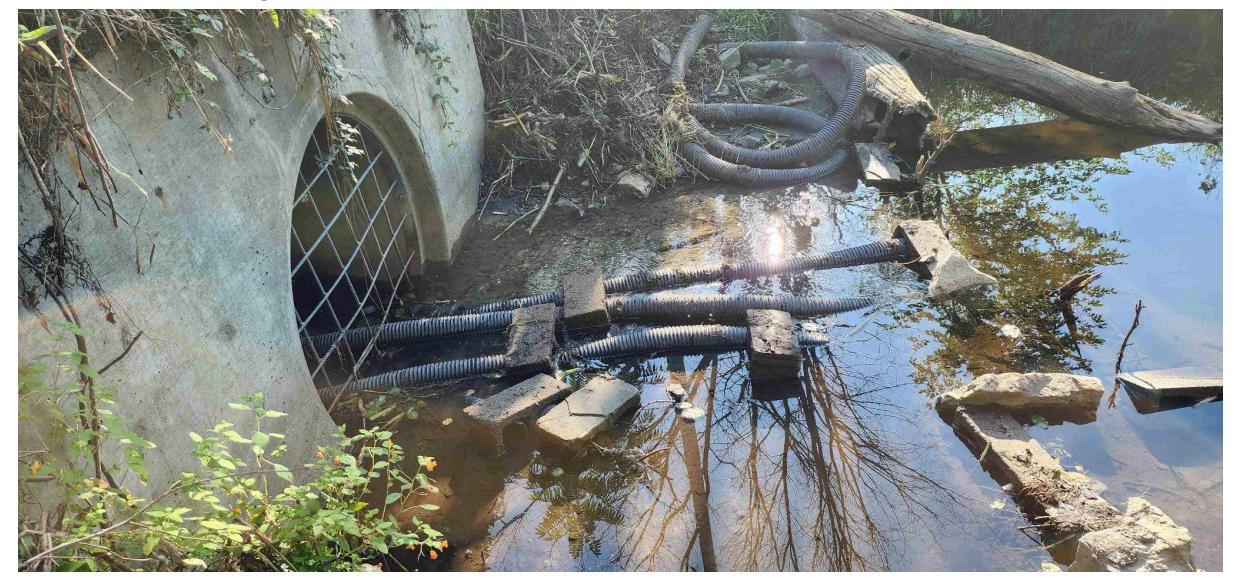
Site before cleaning

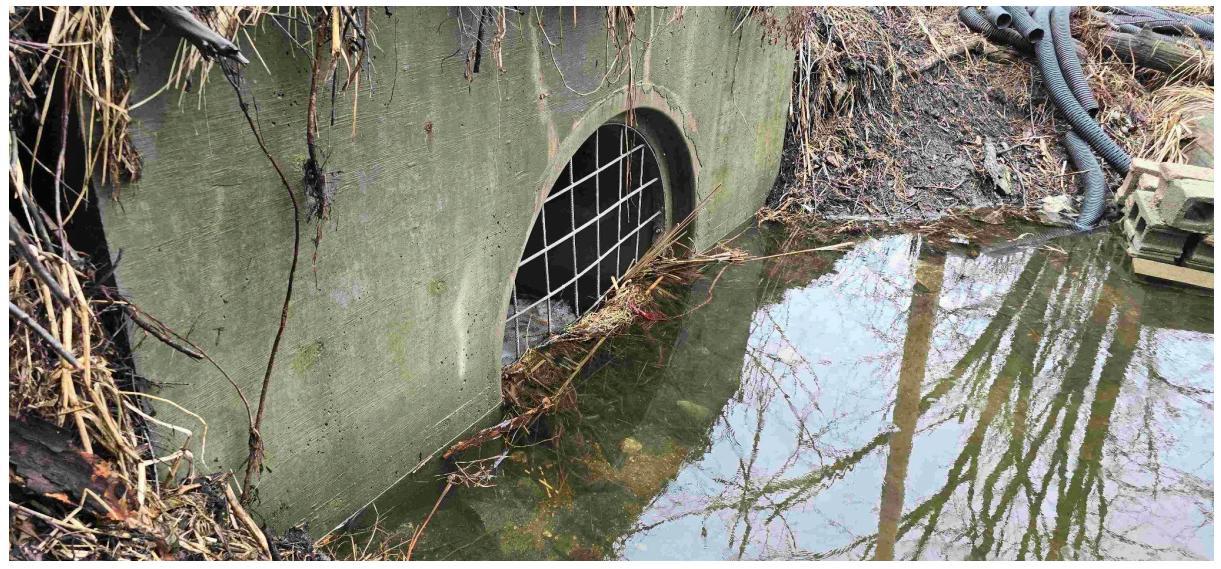
Site after cleaning, showing some debris/damming

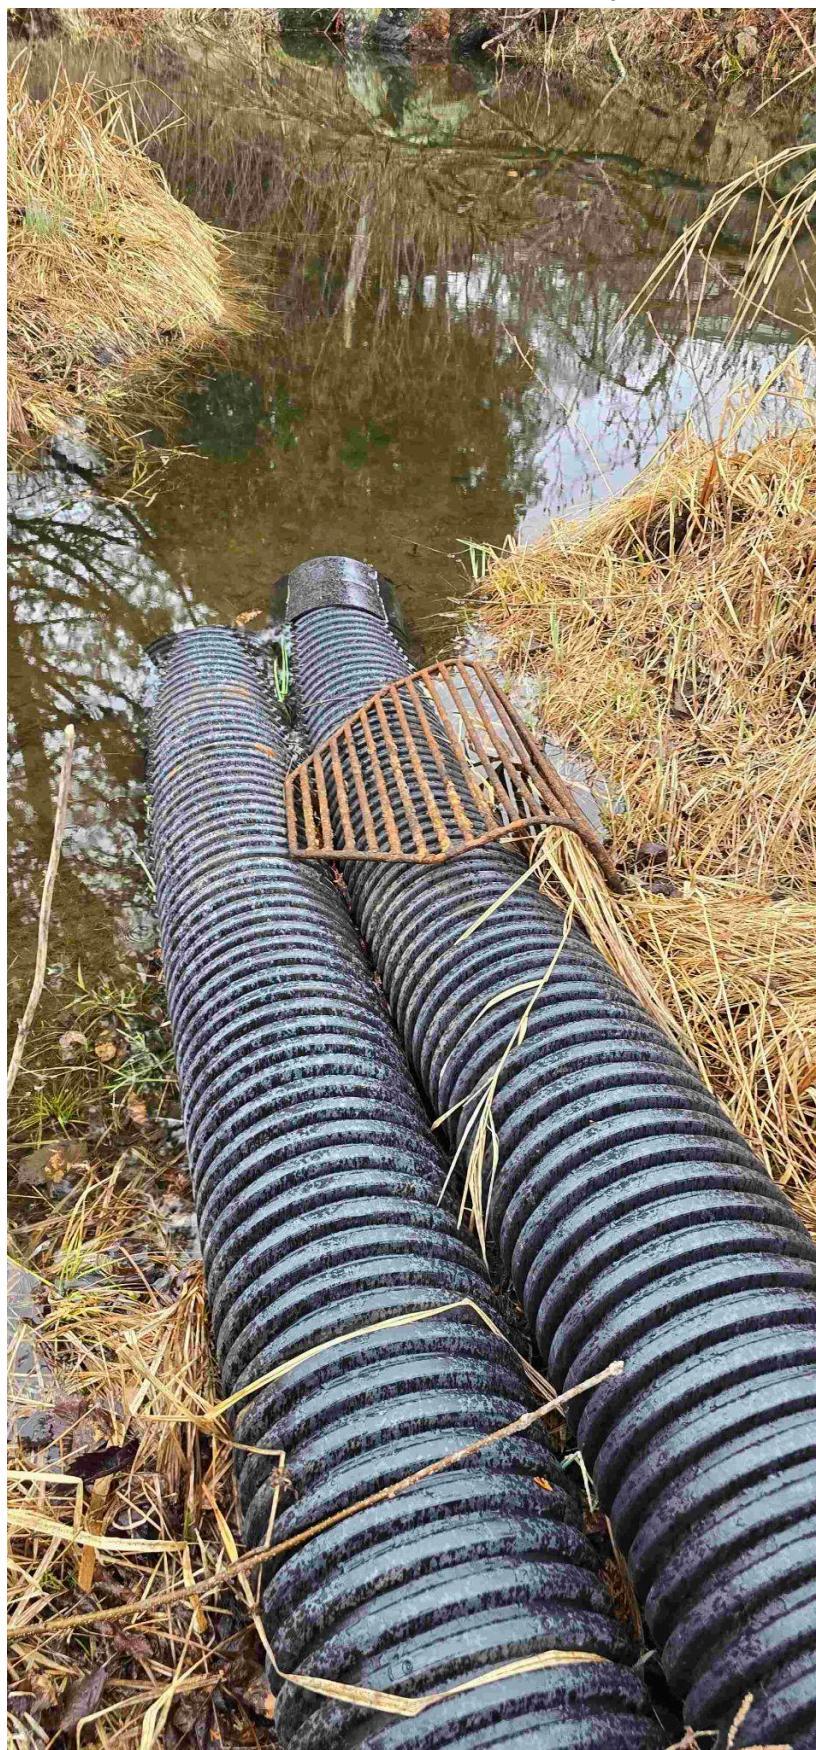
Pipes and coupler recovered from previous project

These are 12in diameter, 20ft long, single wall, corrugated plastic pipe. Two of these were already on site, having been used in a previous project. A coupler was also located on site to allow both lengths to be joined end to end, providing a total length of 40ft. The coupling was reinforced with self-tapping screws to prevent any chance of disassembly.

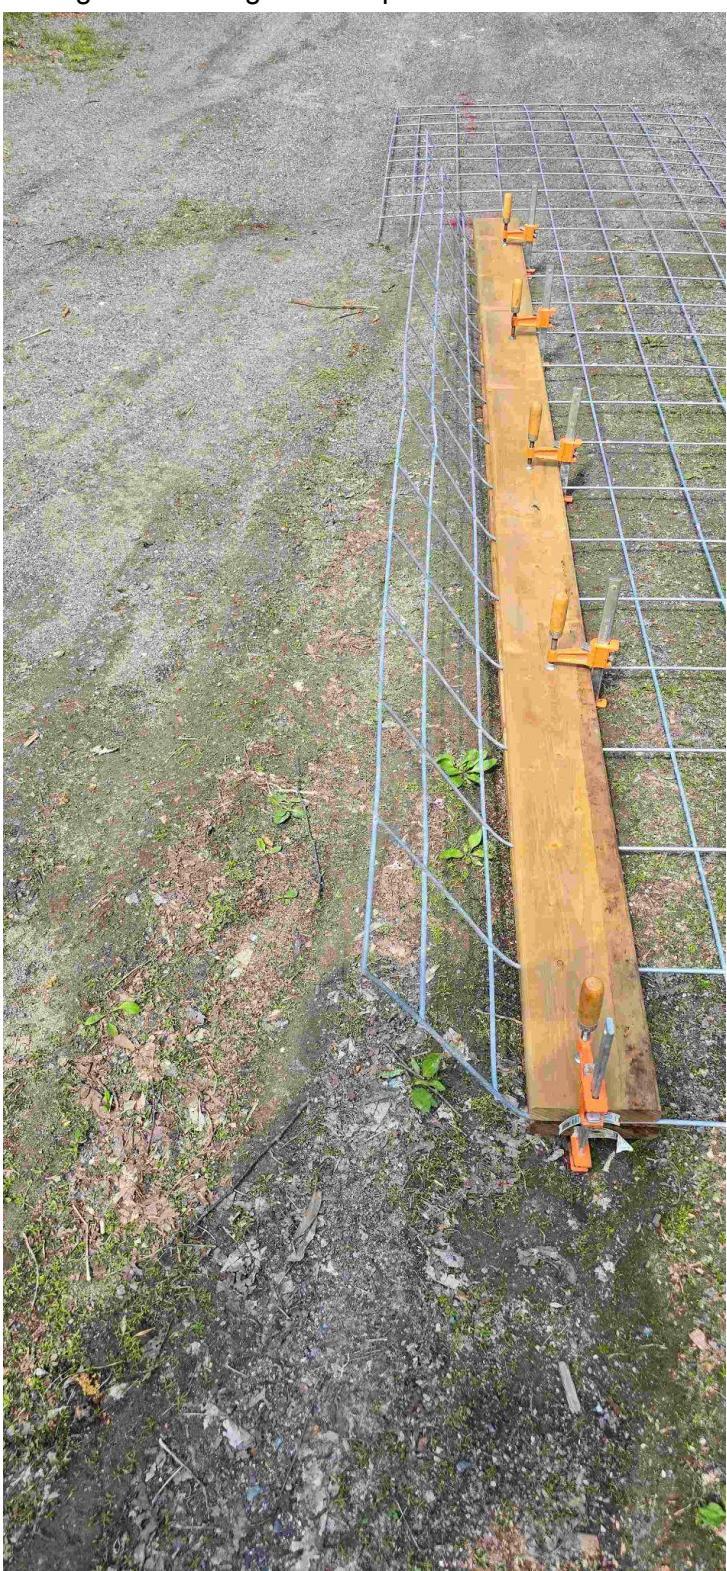
Cutting and bending of mesh panels

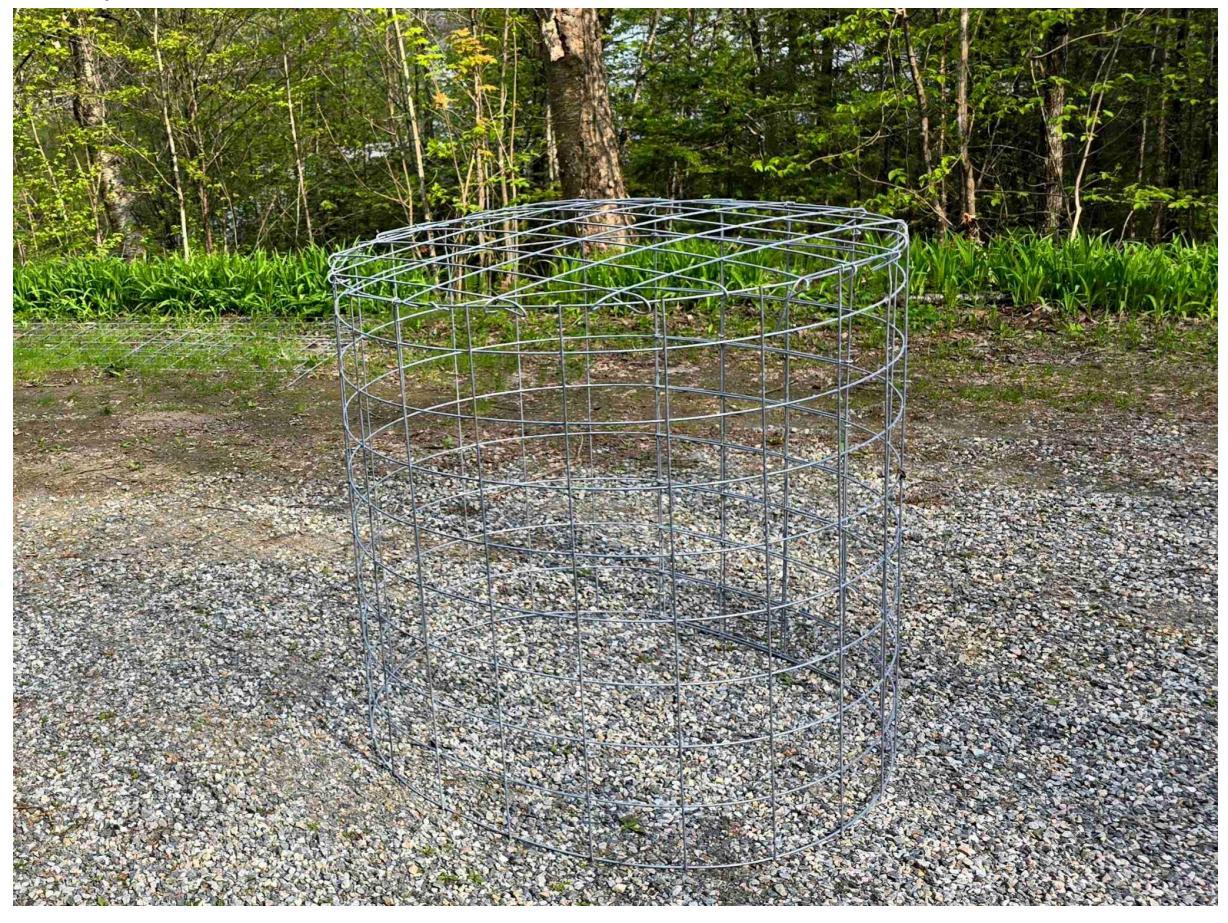
Mesh cylinder

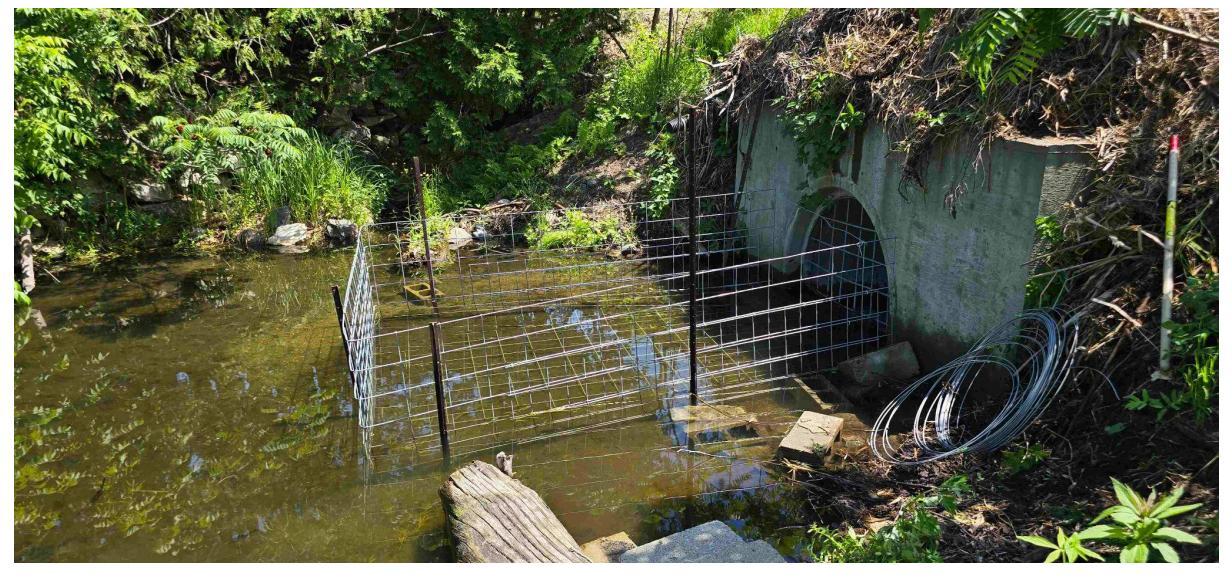
Trapezoid shortly after installation

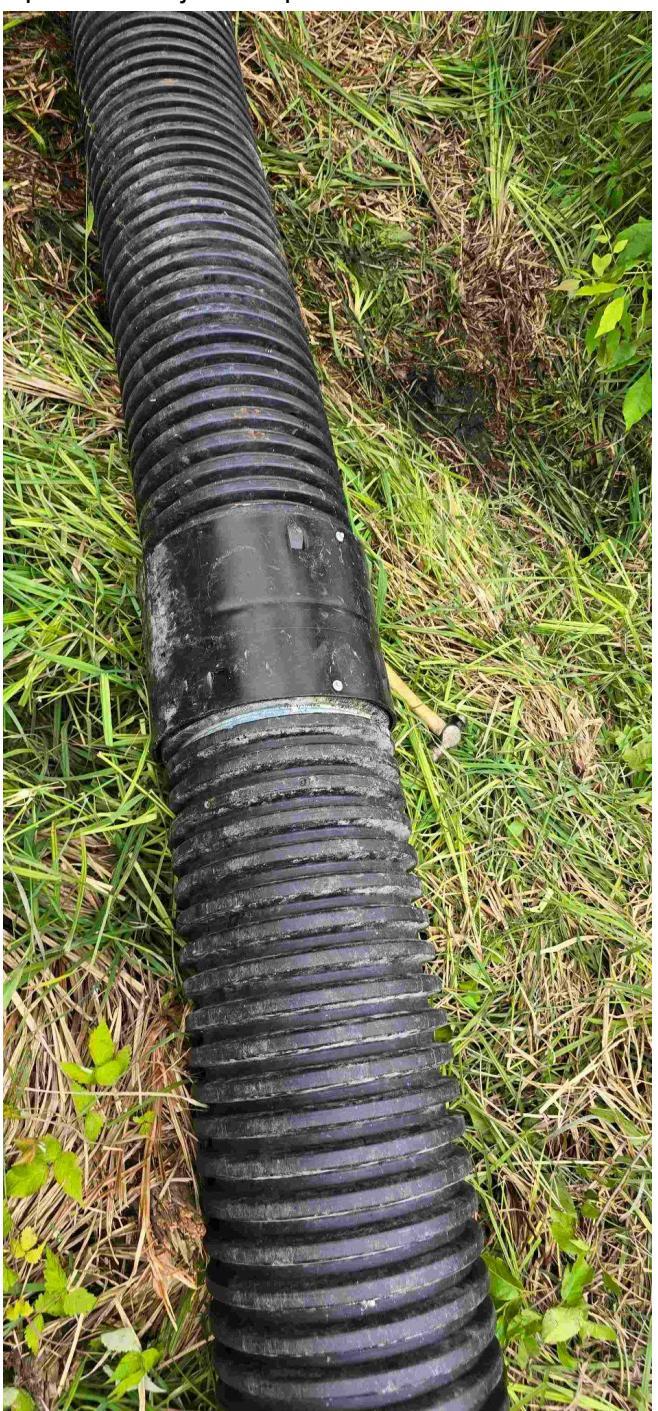
Pipe sections joined up and reinforced

Dealing with the pipe was also pretty easy and extra attention was shown to the joint between the two to ensure that they would not separate after installation. Holes were drilled at the top of the pipe, all along its length, with a half-inch drill bit.

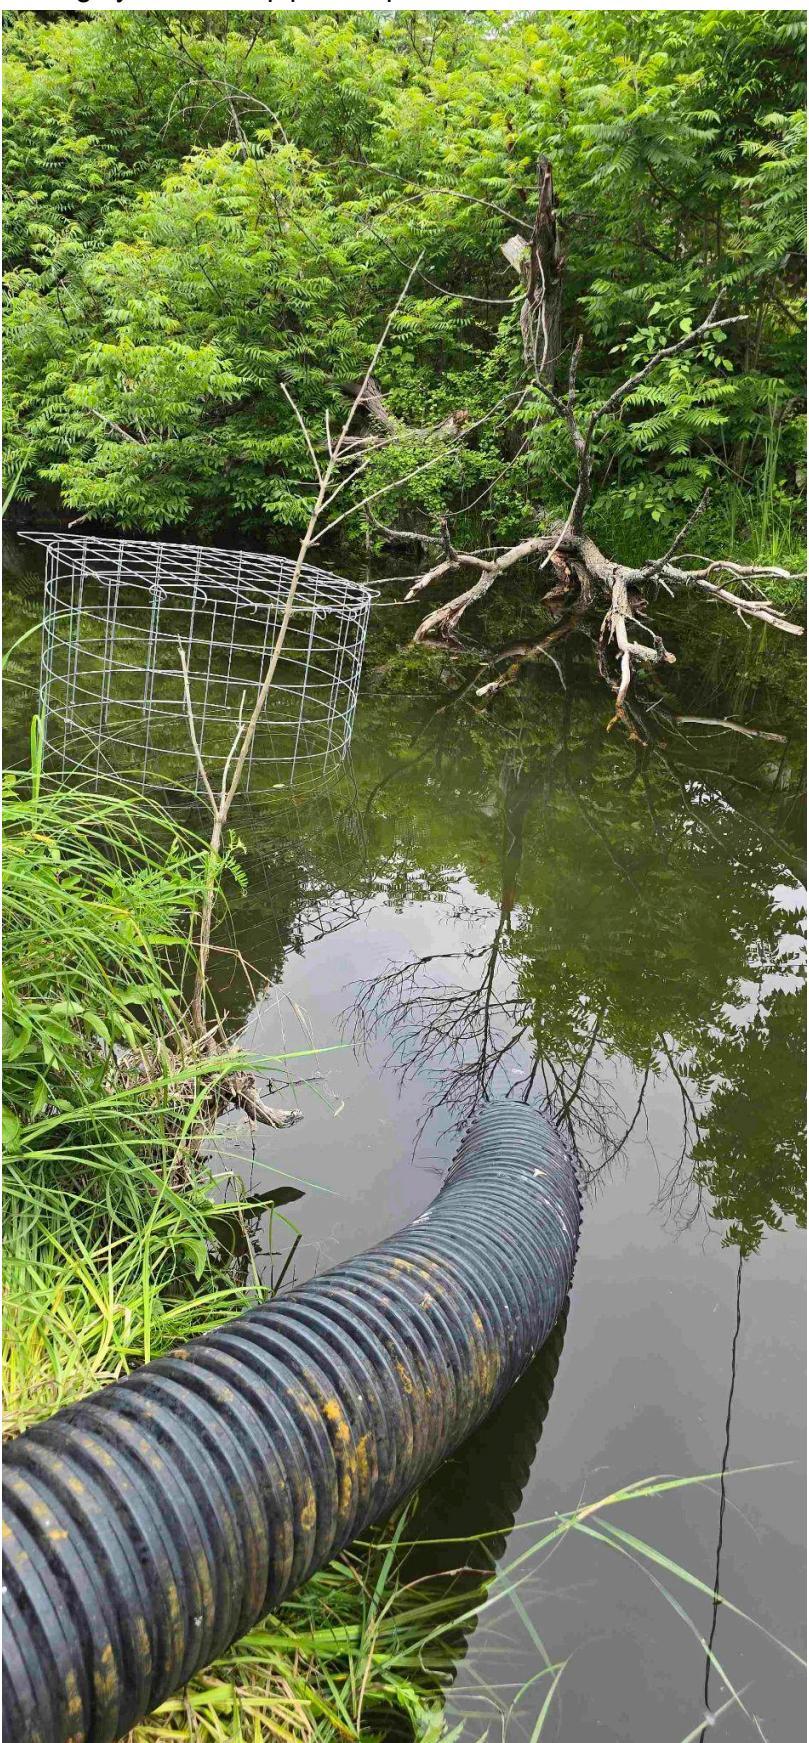
Moving cylinder and pipe into place

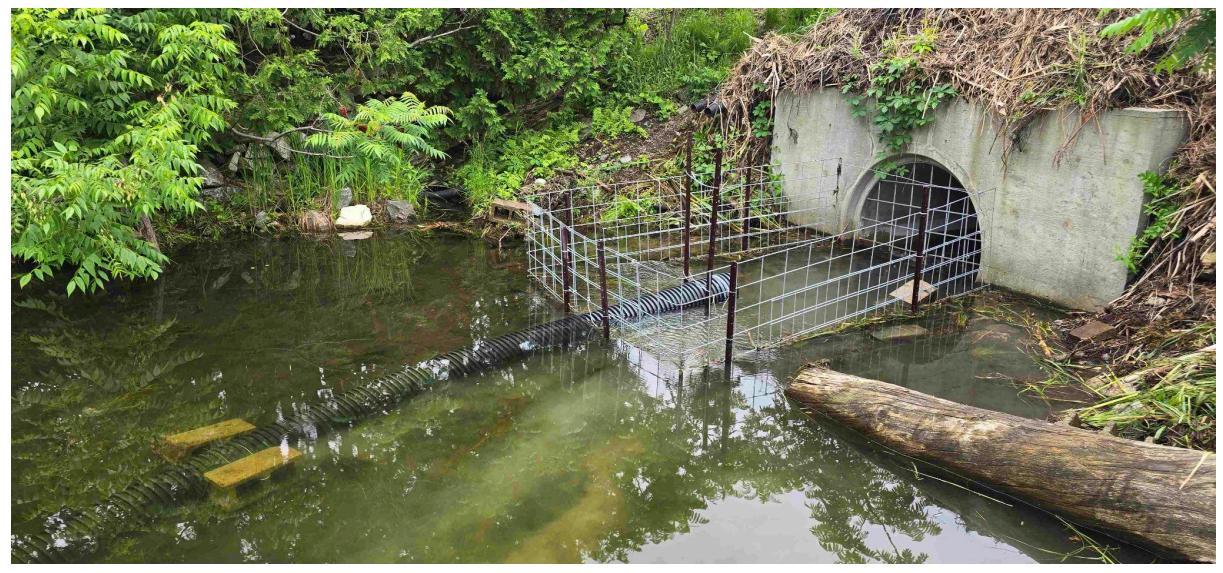
Pipe installed within trapezoid (with cinder block anchor)

Anchors for the pipe were constructed by joining two cinder blocks in a manner that created a type of saddle. These were dropped over the pipe in two locations in order to prevent the pipe from floating up should any gases form within. The pipe inlet and outlet were wired into place within the mesh cylinder and trapezoid in a manner that kept them in place and in the correct position.

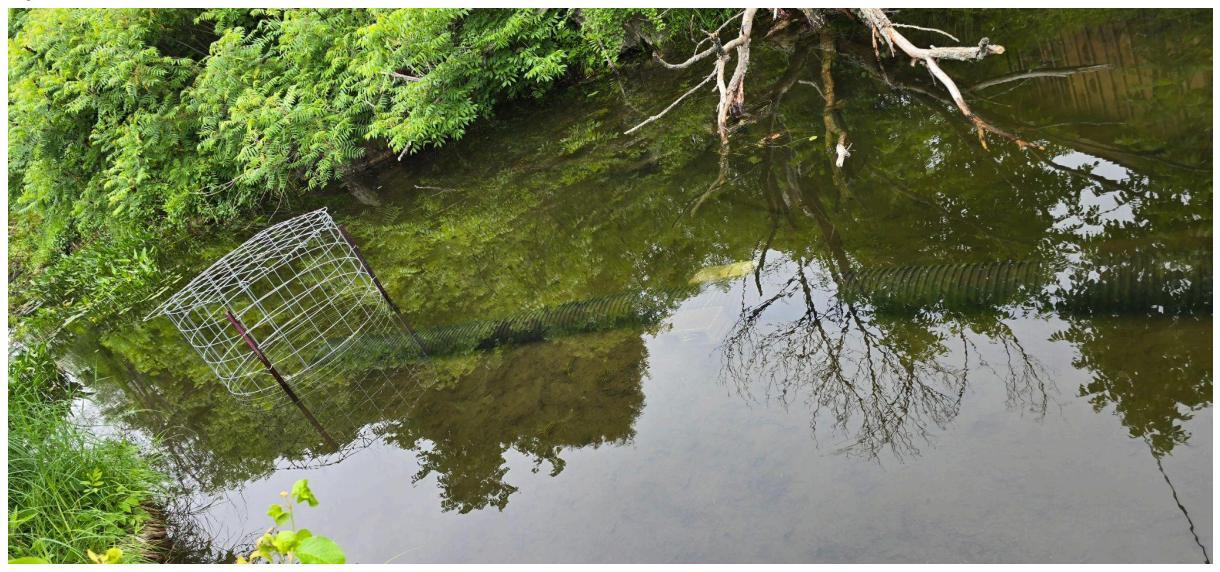
Cylinder in place

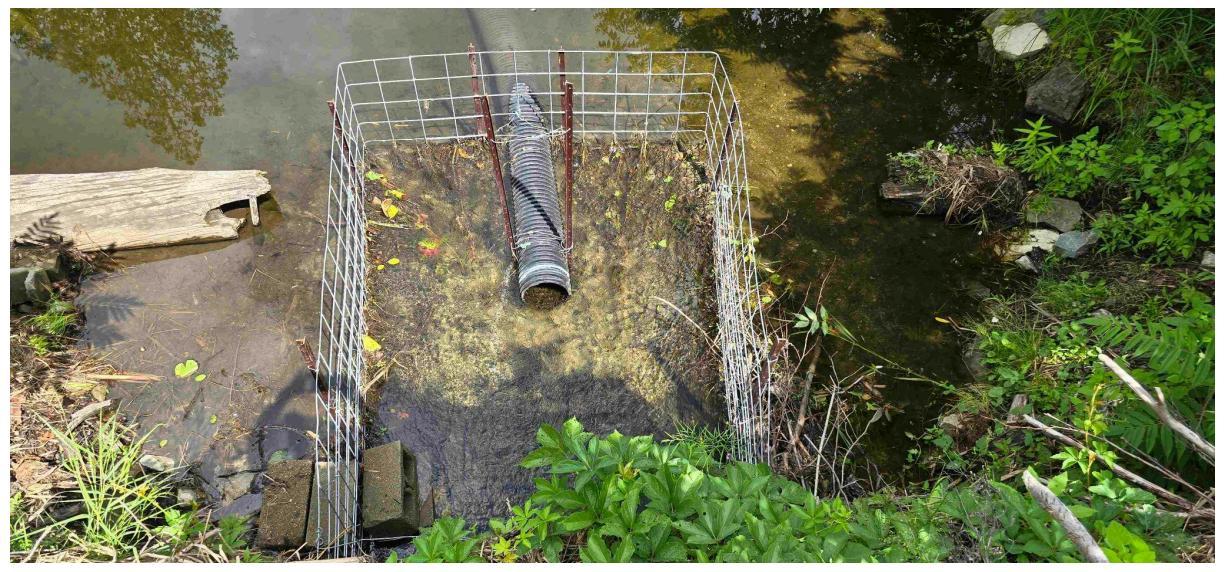
In the months since installation, there seems to have been little, if any, additional attempts at damming. The mud around the perimeter of the trapezoid does impede some flow but as soon as the water level rises, it overflows the mud and is allowed to flow unimpeded through the culvert. If the beavers decide to dam around the trapezoid, the pipe should take over and allow the water to flow. This is the main function of the system.

Trapezoid in operation showing some damming

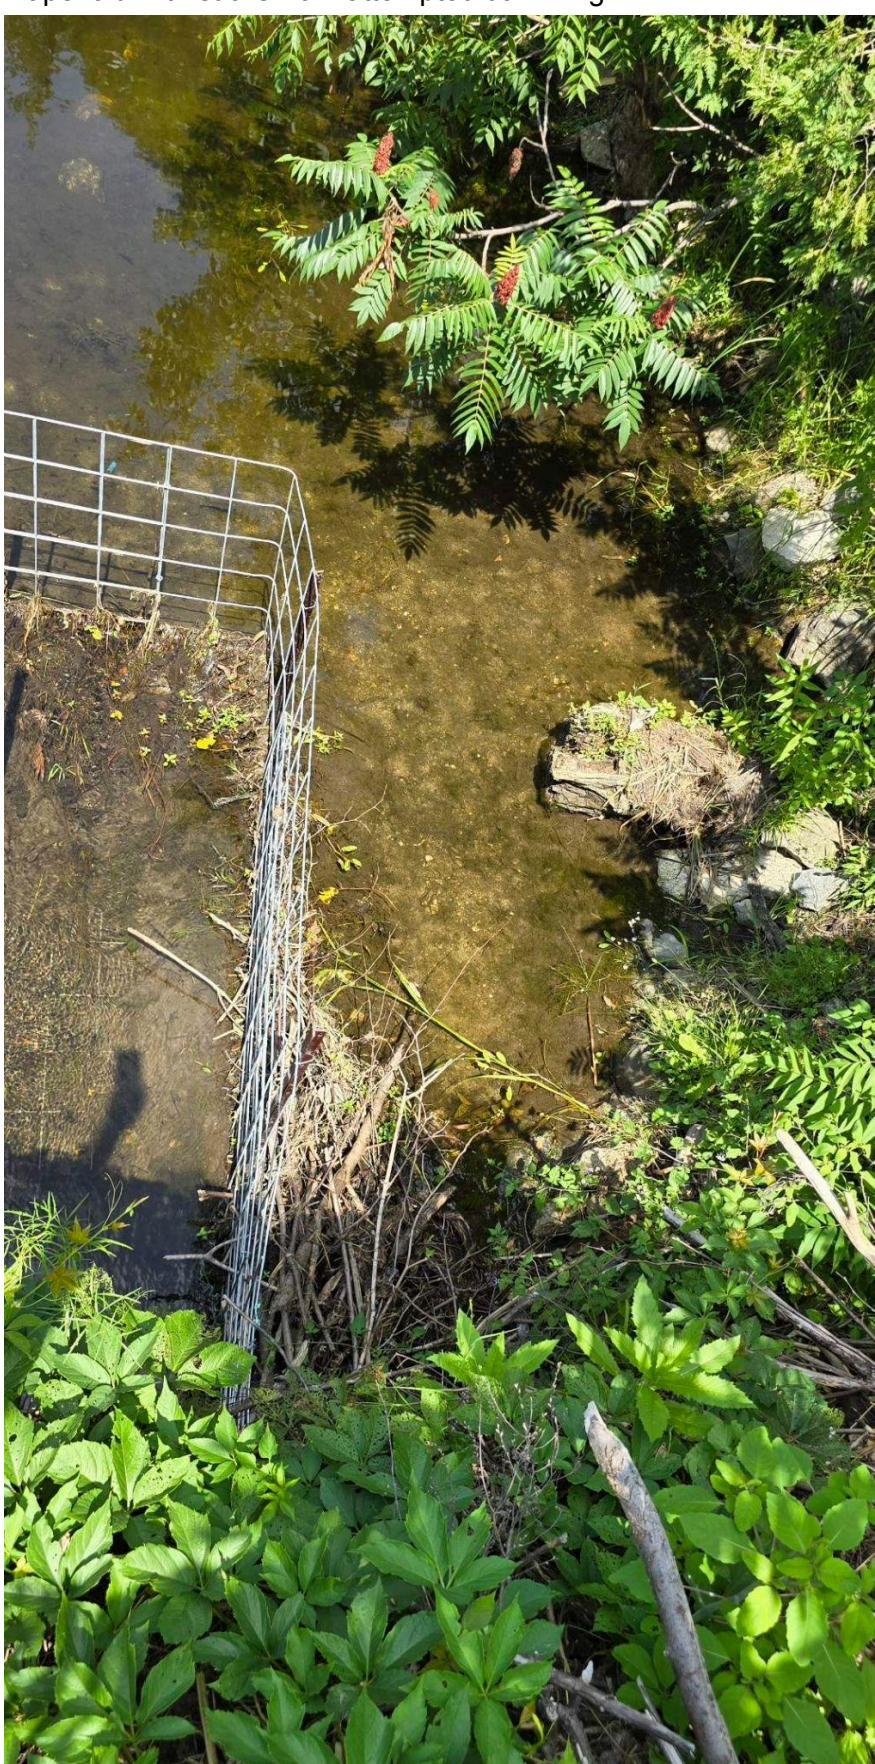
After installation, the beavers did try to dam up close to the culvert but after a few attempts, they gave up. This is apparent from the sticks that they used at the trapezoid. It is important that these should be left in place to discourage them from trying again. They do not impede the flow of water. The beavers also tried to dam around the perimeter of the trapezoid using mud and vegetation but also gave it up. Again, the mud should be left in place to discourage further activity.

Trapezoid with sticks from attempted damming
